**Massachusetts Department of Environmental Protection**  
**Bureau of Resource Protection – Watershed Permitting Program**  
**Sanitary Sewer Overflow (SSO)/Bypass**  
**Notification Form**

Hull, MA WPCF

- Location: Occurred at 26 Western Ave. Hull, MA 02045; detached garage on property.  
(Description of discharge site or closest address)
5. Estimated SSO Volume at time of this Report: Estimated by visual and surface area of the garage & depth of liquid. 360 gallons  
Method of Estimating Volume: Visual & calculated  
Other Method: \_\_\_\_\_

## Work Order - Backup or Blockage Call

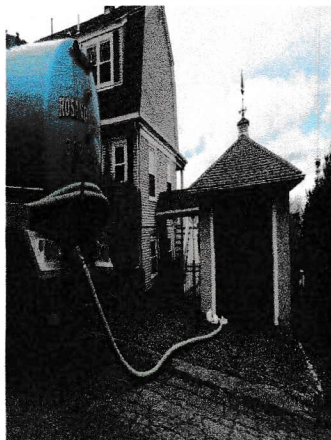
Notes: W&C TV work, Rasano Davis Pump Truck and jetter work. After heavy rains house 26 continued to have blockage backup contained in garage.

Service: ES, BB, and AV all worked with Rasano Davis in attempt to jet line. It has been difficult to jet and camera by #26 because it is in the middle of a 600 foot sewer on steep hill with 6" over 100 year old clay. Jetter was able to remove some debris and additional camera work found pipe upstream to apx 50 ft. from house in fair to good condition.

< 20 gallons  
in garage

Attempted to  
Dye test from upstream  
m Hole to downstream  
m Hole. Dye not seen.

Dye did come out through  
floor drain in garage  
as pump truck was  
vacuuming up the liquid

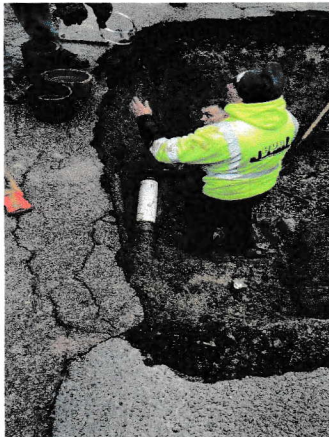
**Notes:** Downstream of house #26 on western ave HuB construction excavated down 6 feet to sewer main where a jetter truck had previously hit something. An offset joint was repaired but was found not to be the cause of the blockage. An inspection port was also made in the sewer main

WRiver camera up 20' +  
down 130'  
PIPE IN SATISFACTORY CONDITION

Inspection port in main replaced

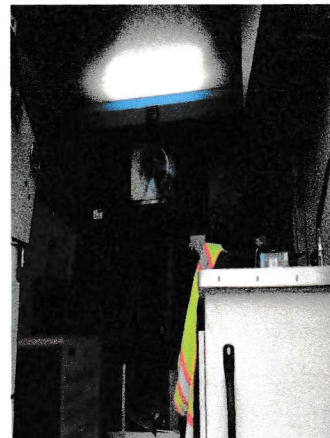
TV truck

GARAGE AREA  
not overflowing

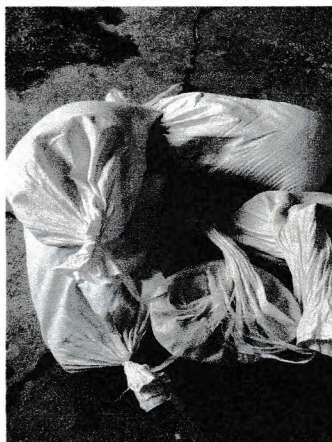
**Notes:** Partial blockage remaining in Street. Checking on resident garage floor drain

**Service:** Inspected garage floor drain at 26 western ave. Once in morning and once in afternoon. No change no overflow occurring at this time.

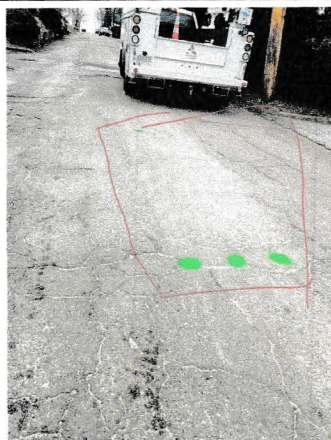
**Service:** Arrive at 7am, there until 10 am with WRIVER vac/jet truck. Mike Decosta and Jason from WR. Mark road where suspected blockage area is. Inform homeowner, Town, & Hub construction.

inspect #26 12/31/16  
Western Ave two  
times later in day  
area not overflowing

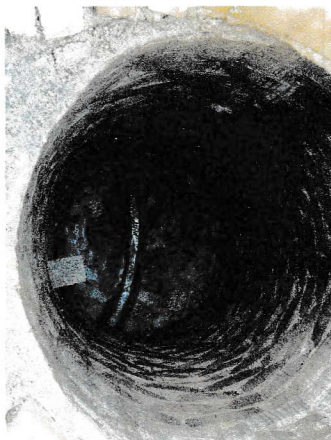
**Asset:** MH 20038

**Service:** Vac out brick pieces with WRiver and attempt to jet down the street, but unable to, since liquid in drain in #26 garage started to rise.

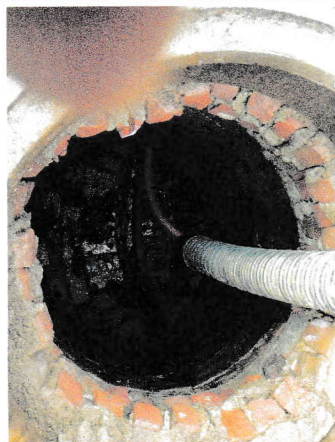
Asset: MH 20051

Service: Jet line 6 to 7 times. Only able to get out approx 140 ft. Mark location on road.

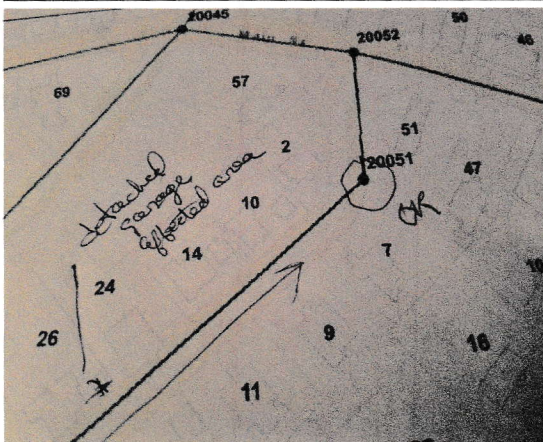
**Manhole ID:** MH 20051

**Service:** Inspect at approx 3pm - downstream of back up. Flowing ok. At bottom of hill by main street.

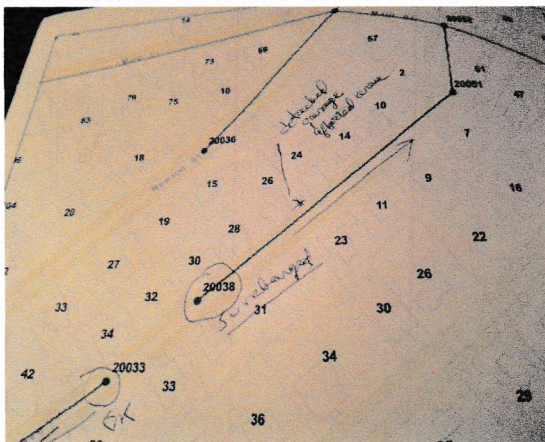
**Date:** 12/30/2016      **Type:** Inspections      **Status:** Completed  
**Manhole ID:** MH 20038      **Priority:** Normal      **Reason:** Operational

**Notes:** Surcharged manhole

**Service:** Approx 230pm, found this manhole surcharged. Made a number of calls. Only Rosano-Davis available. Pump out manhole and found brick pieces.

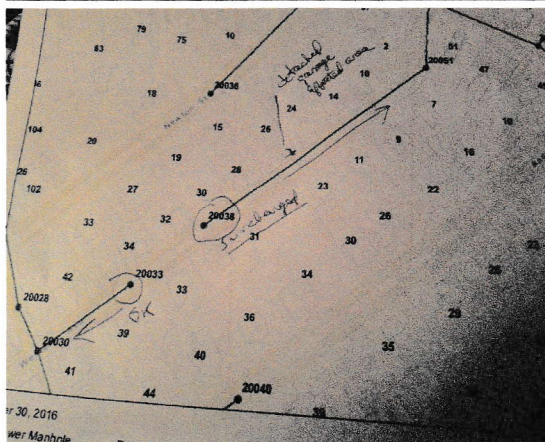
**Manhole ID:** MH 20033

**Notes:** Inspect and normal. Flow is toward Highland Ave. (Away from the affected area)

**Service:** 1pm check - Manhole is OK. Not part of affected area.

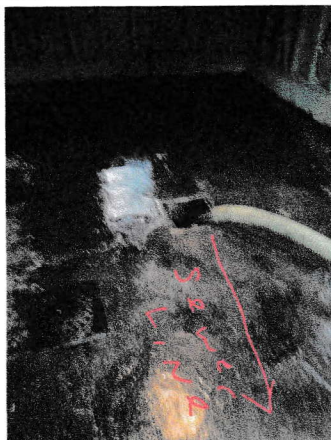
**Service:** Visit location at 1230pm, sewage coming up through floor drain in garage. Inspect street manholes & found #20388 surcharged. Rosano Davis only pumper/contractor available. Still blockage in street. Clean garage area & set up for vector truck on Sat.
